**Tree Inventory and Preservation Plan Report
The Queensway and Fordhouse Boulevard
Toronto, Ontario**

31 October 2024

KUNTZ FORESTRY CONSULTING Inc. Project P4351

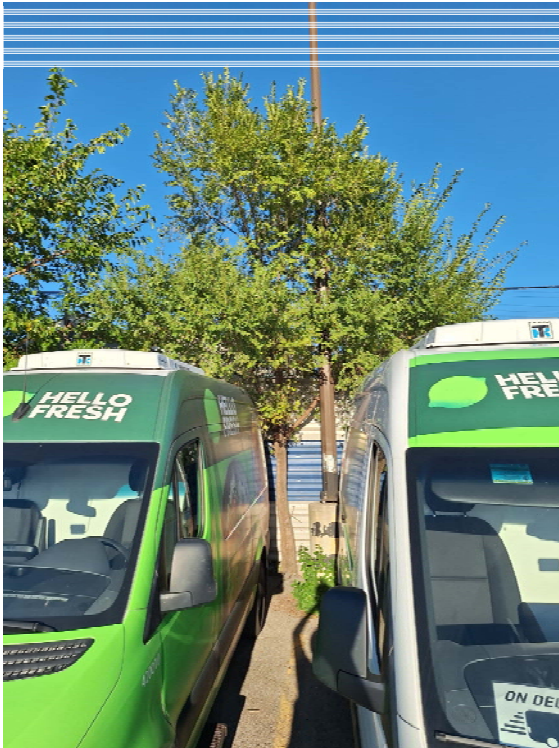
Image 1. Tree 271

Tree #	Common Name	Scientific Name	DBH	TI	CS	CV	DL	CDB	mTPZ	cat	Comments	Ownership	Action	Comp.
271	Siberian Elm	<i>Ulmus pumila</i>	16	FG	F	F	3		1.8		Co-dominance at 1.8m, restricted root zone (H), asymmetrical crown (M), graze (M), poor form (L)	Private	Remove	
272	White Mulberry	<i>Morus alba</i>	~7-17	PF	F	FG	3.5		1.8		Co-dominance at 0.4m and 1.7m (many stems), poor form (H), slime flux (M), epicormic shoots (M)	Private	Remove	
273	Eastern Cottonwood	<i>Populus deltoides</i>	19, 15, 12.5	F	G	FG	3		1.8		Co-dominance at base and 0.5m (3 stems), included fence (M), leaf blight (L)	Private	Remove	
A	Siberian Elm	<i>Ulmus pumila</i>	~41	FG	FG	FG	6		3.0	2	Obstructed by metal fencing, broken branches (L), deadwood (L), hydro lines through crown	Shared with Neighbour	Remove	3
B	Columnar English Oak	<i>Quercus robur</i> 'Fastigiata'	8-20.5	FG	G	FG	1.5		1.8		Co-dominance at 1 and 1.4m (4 stems), leaf blight (L)	Neighbour	Preserve

The removal of eight trees, including Trees 271-273, A, and N-Q will be required to accommodate the proposed development. Trees 271, 272, A, and N-Q conflict with excavation required for the underground parking. Tree 273 directly conflicts with the proposed development.

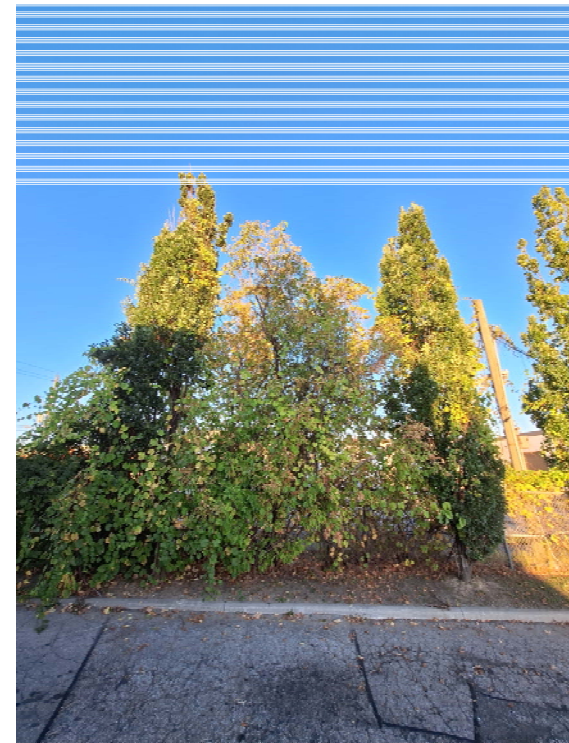
Image 6. Trees C-E (L-R)

C	Columnar English Oak	<i>Quercus robur</i> 'Fastigiata'	~22	PF	F	F	1.5		1.8		Stem wound (H), vine competition (M)	Neighbour	Preserve	
D	Manitoba Maple	<i>Acer negundo</i>	~19	F	PF	PF	3		1.8		Epicormic shoots (H) at base, poor form (M), vine competition (H)	Shared with Neighbour	Preserve (injure)	
E	Columnar English Oak	<i>Quercus robur</i> 'Fastigiata'	~16	FG	FG	FG	1.5		1.8		Co-dominance at 1.8m (3 stems), vine competition (L)	Neighbour	Preserve	
F	Siberian Elm	<i>Ulmus pumila</i>	~22, 20, 14	PF	PF	PF	4.5		1.8		Co-dominance at base (3 stems), epicormic shoots (L), included fence (H), poor form (M), deadwood (M)	Shared with Neighbour	Preserve (injure)	
G	Siberian Elm	<i>Ulmus pumila</i>	~21, 18, 16	PF	F	F	5		1.8		Co-dominance at base (3 stems), epicormic shoots (L), included fence (M)	Shared with Neighbour	Preserve	
H	Siberian Elm	<i>Ulmus pumila</i>	~22	PF	FG	FG	4.5		1.8		Co-dominance at 2m, included fence (H), deadwood (L), vine competition (L)	Shared with Neighbour	Preserve

Encroachment into the mTPZs of Trees D, F, and K will be required to accommodate the and the installation of a new curb along the proposed public roadway. Tree preservation has been prescribed within the mTPZs of these trees at the anticipated limit of disturbance. If the following mitigation measures are employed, long-term adverse effects are not anticipated for these trees.

1. Tree preservation fencing should be installed, as depicted on Figure 1, and maintained throughout the duration of the construction process.
2. The existing asphalt should be removed carefully, using small machinery (i.e. a skidsteer).

3. Any roots encountered in the subsurface material should be left intact.
4. Once the existing asphalt has been removed, no machinery use will be permitted within the mTPZs of these trees.

5. Air-spade or low-pressure hydro-vacuum technology should be used to excavate trenches, in the locations indicated on Figure 1, under the supervision of a Certified Arborist.

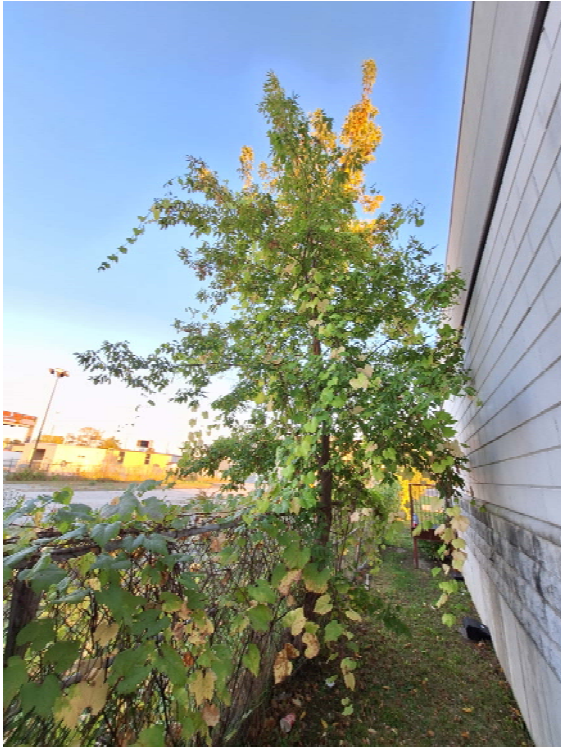
Image 10. Tree I

I	Manitoba Maple	<i>Acer negundo</i>	~18	P	F	F	2.5		1.8		Included fence (H), stem wound (H), vine competition (L), poor form (M)	Shared with Neighbour	Preserve

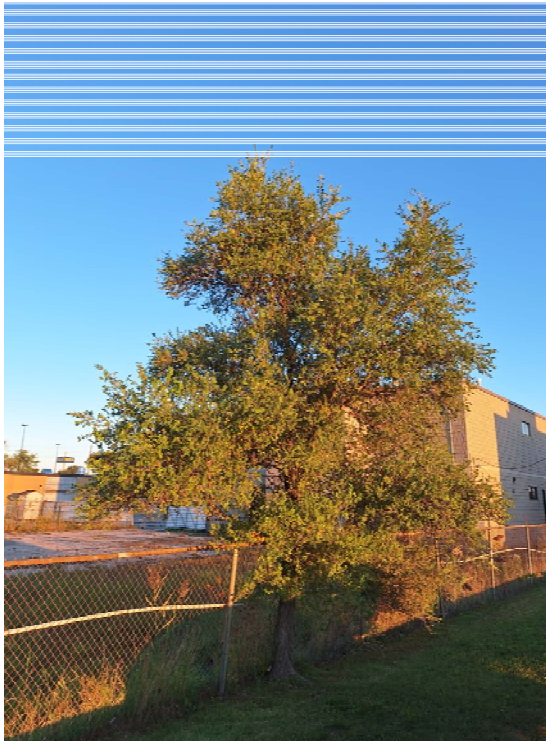
Image 11. Tree J

J	Siberian Elm	<i>Ulmus pumila</i>	~20	FG	G	G	3		1.8		Included fence (L), co-dominance at 2.5m	Shared with Neighbour	Preserve	
K	Siberian Elm	<i>Ulmus pumila</i>	~15	FG	FG	FG	3		1.8		Included fence (L), epicormic shoots (L), deadwood (L)	Shared with Neighbour	Preserve (injure)	
L	Thornless Honey Locust	<i>Gleditsia triacanthos inermis</i>	19.5	G	FG	G	4.5		1.8		Exposed roots with mechanical damage, broken branches (L)	Neighbour	Preserve	
M	Thornless Honey Locust	<i>Gleditsia triacanthos inermis</i>	21.5	G	G	G	4.5		1.8		Exposed roots with mechanical damage, pruning wounds (L)	Neighbour	Preserve	
N	Siberian Elm	<i>Ulmus pumila</i>	~18, 16	PF	FG	FG	4		1.8		Co-dominance at base, inclusion (M) (assessed from distance due to accessibility)	Shared with Neighbour	Remove	
O	Siberian Elm	<i>Ulmus pumila</i>	~15	F	FG	FG	2.5		1.8		Bow (M) (assessed from distance due to accessibility)	Shared with Neighbour	Remove

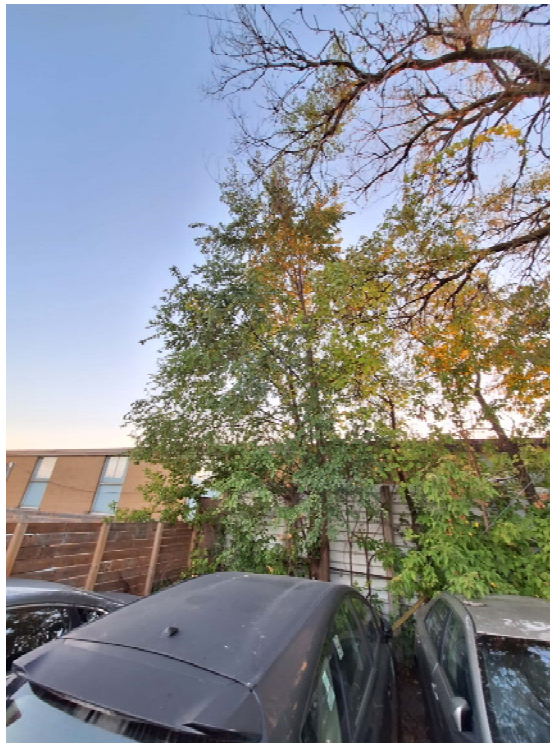
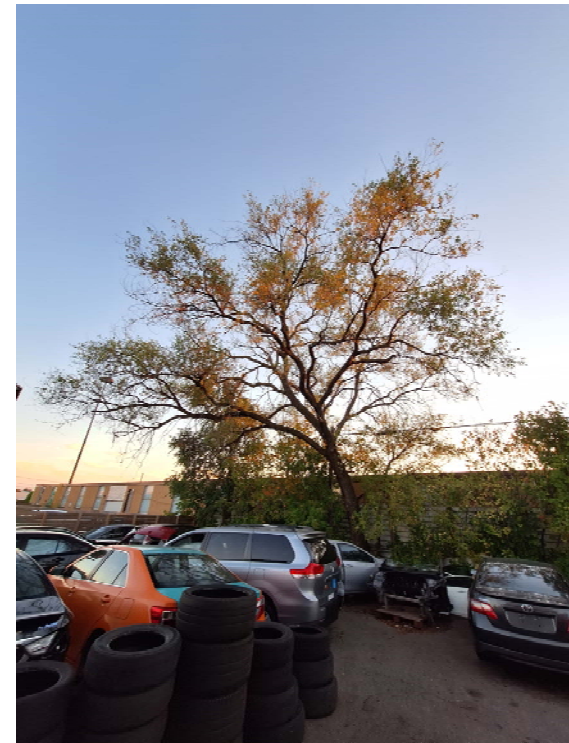
Image 14. Trees N and O (L-R)

P	Siberian Elm	<i>Ulmus pumila</i>	~57.5, 15	F	FG	F	9		3.6	2	Bow (M), inclusion (M), asymmetrical crown (L), pruning wounds (M), hydro lines through crown	Shared with Neighbour	Remove	3
Q	Manitoba Maple	<i>Acer negundo</i>	17	FG	FG	G	3		1.8		Restricted root zone (H), co-dominance at 2m, hydro lines through crown	Shared with Neighbour	Remove

from the respective landowners must be obtained prior to the removal of Trees A and N-Q.
